## **RESOLUTION #11 of 2004**

A RESOLUTION OF THE BOARD OF SUPERVISORS OF MOUNT JOY TOWNSHIP, ADAMS COUNTY, PENNSYLVANIA, AUTHORIZING THE ZONING OFFICER AND THE SOLICITOR TO TAKE SUCH ACTIONS AS ARE NECESSARY TO ABATE A STRUCTURAL HAZARD ON LANDS KNOWN AS 1885 BALTIMORE PIKE.

Re: Building Structure Inspection  
Golden Menu Restaurant  
1885 Baltimore Pike  
Adams County, Pennsylvania

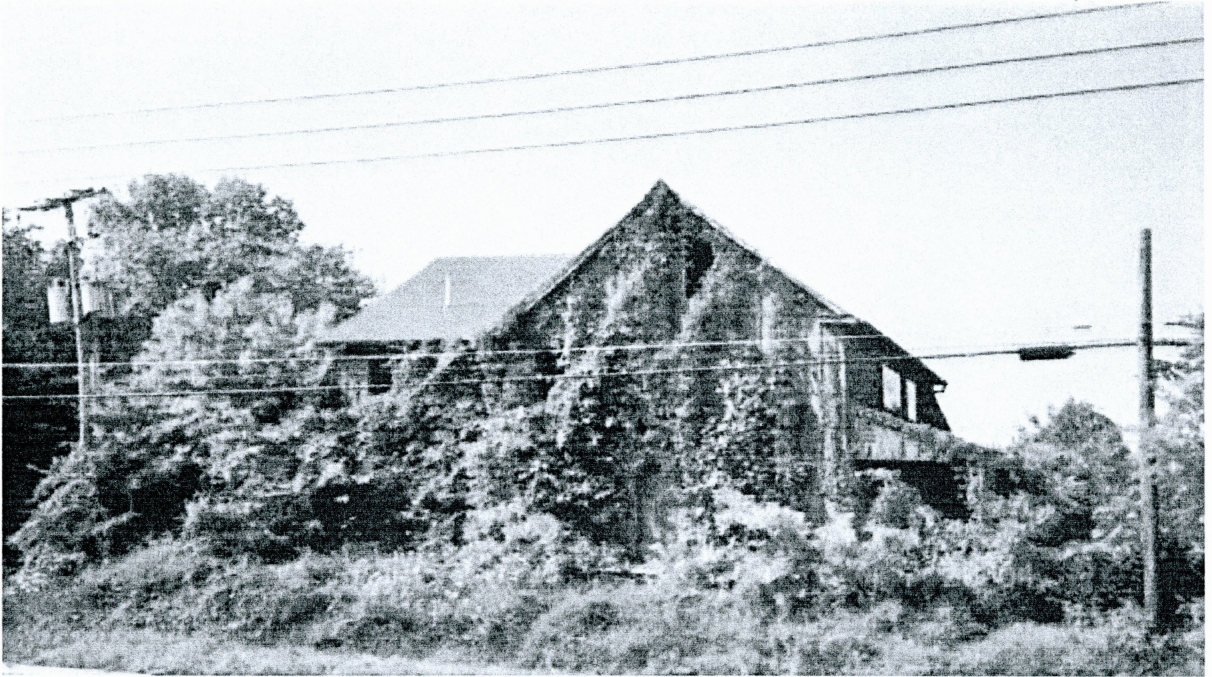
The building in question is a two-story frame structure of unknown age with a basement and attic. The building is unoccupied and has obviously been damaged by fire. It is our understanding that the fire occurred approximately 6 to 8 years ago and the building has remained untouched since that time. The structure is in an obvious state of neglect and disrepair, with a significant portion of the roof destroyed by the fire thus exposing the interior to the elements. Windows are broken out, doors are unsecured and heavy vegetation surrounds the perimeter of the building and adjoining parking lot.

**PHOTO 1 (View of front of building looking from Baltimore Pike)**

the extent of damage. Therefore, we recommend that the building be demolished, and the lower (basement) level be backfilled to grade in order to eliminate the current hazardous conditions.

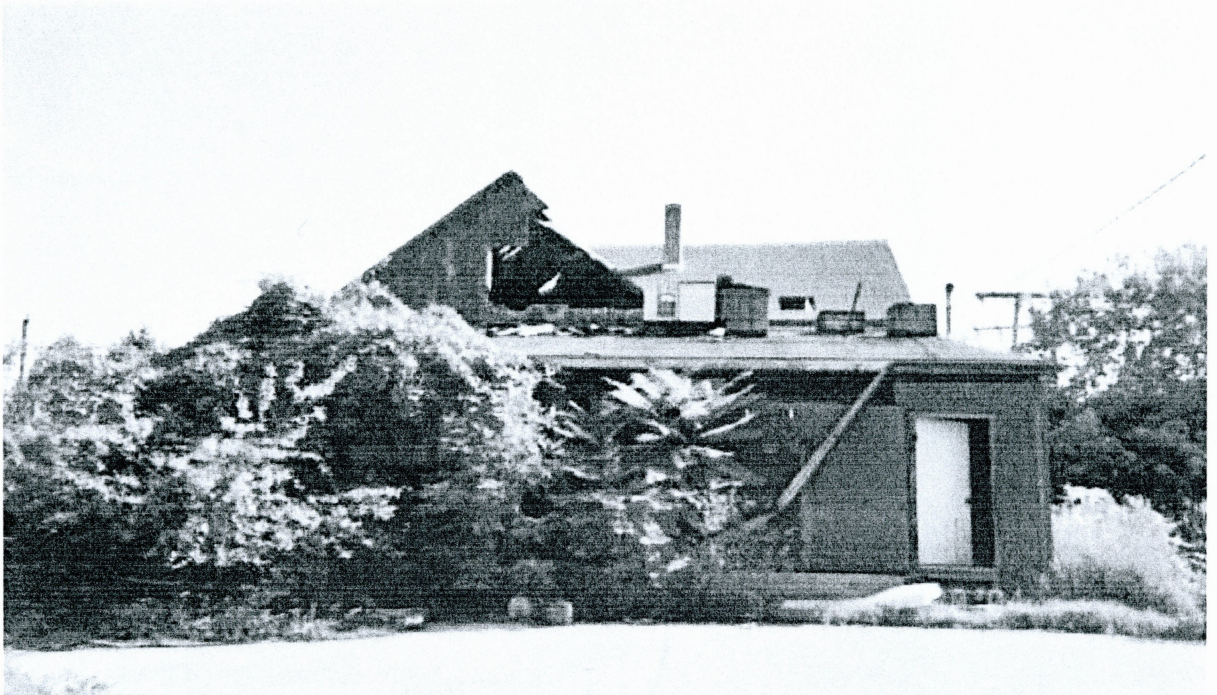
**PHOTO 2 (View of rear of building)**

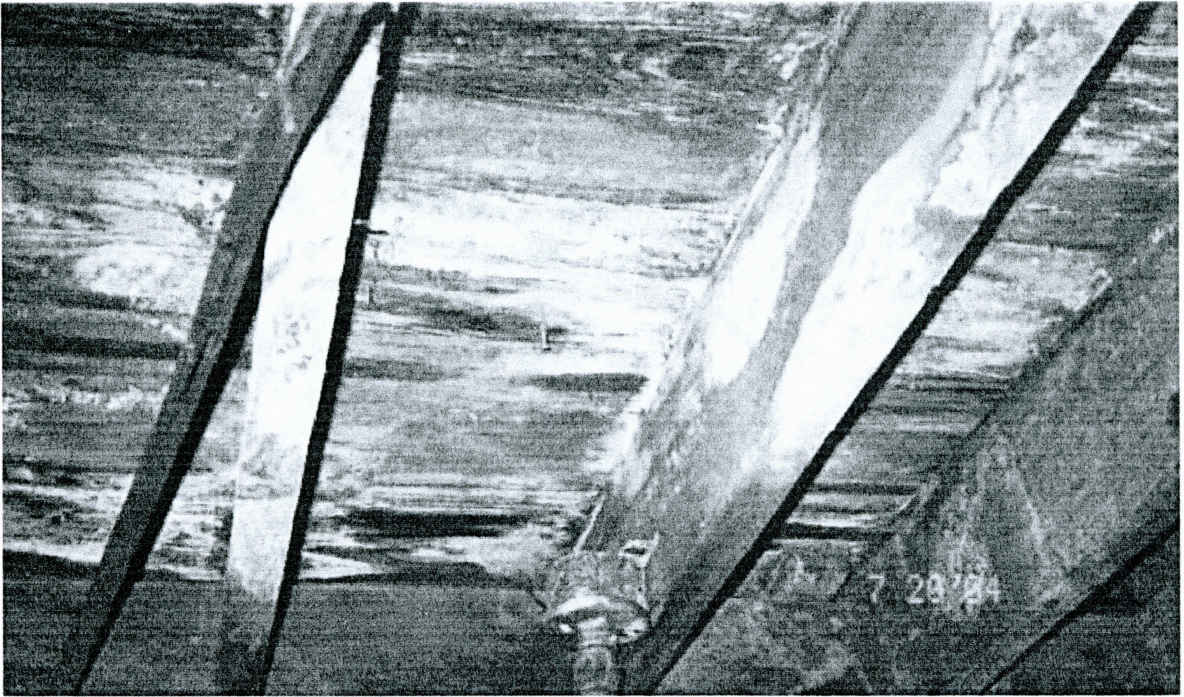
front portion of the basement appears to be older, and contains stone masonry exterior and interior walls and a concrete floor. The first floor in this area is supported by 2" x 10" timber joists spaced at 16" to 18" on center and transverse floorboards. The clear height in this section of the basement is approximately 5'-6". The basement walls contain minor to moderate deterioration of the mortar, while random floor joists, although seemingly in fair condition, exhibit minor rot and/or dry rot on their sides. The floorboards appear to be in a similar condition as well.

**PHOTO 3 (Basement - Typical timber joist and floor board condition in front section)**

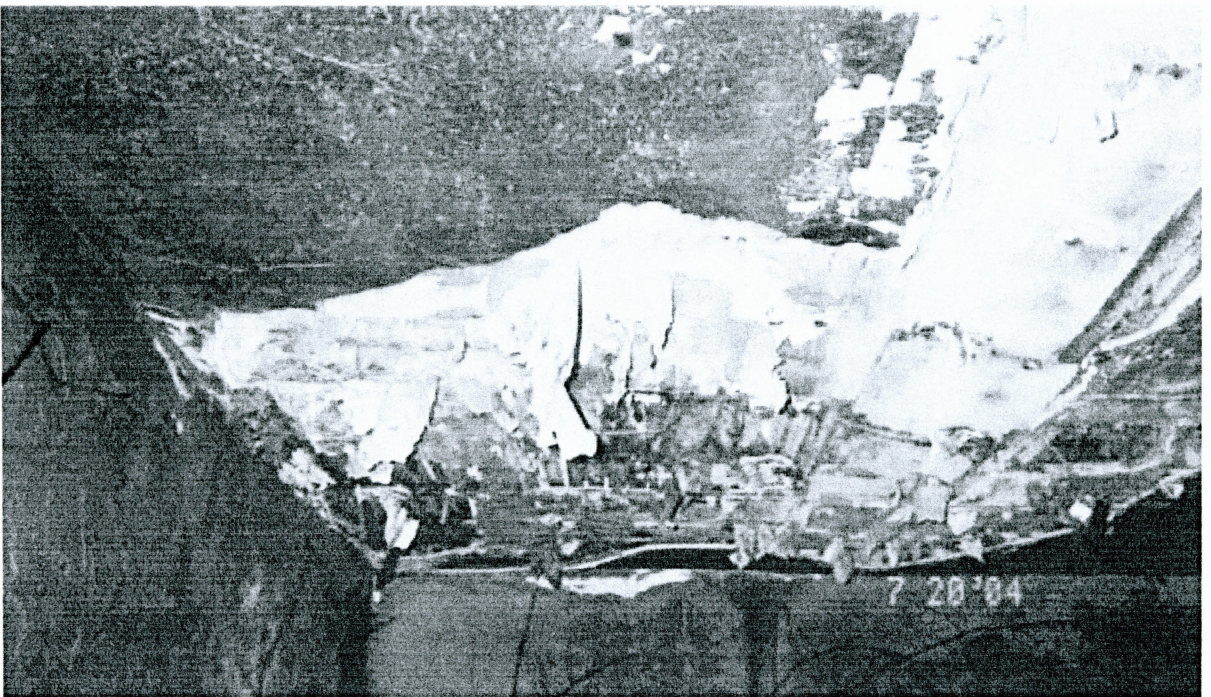
**PHOTO 4 (First Level Rear Dining Room - Ceiling damage and sag)**

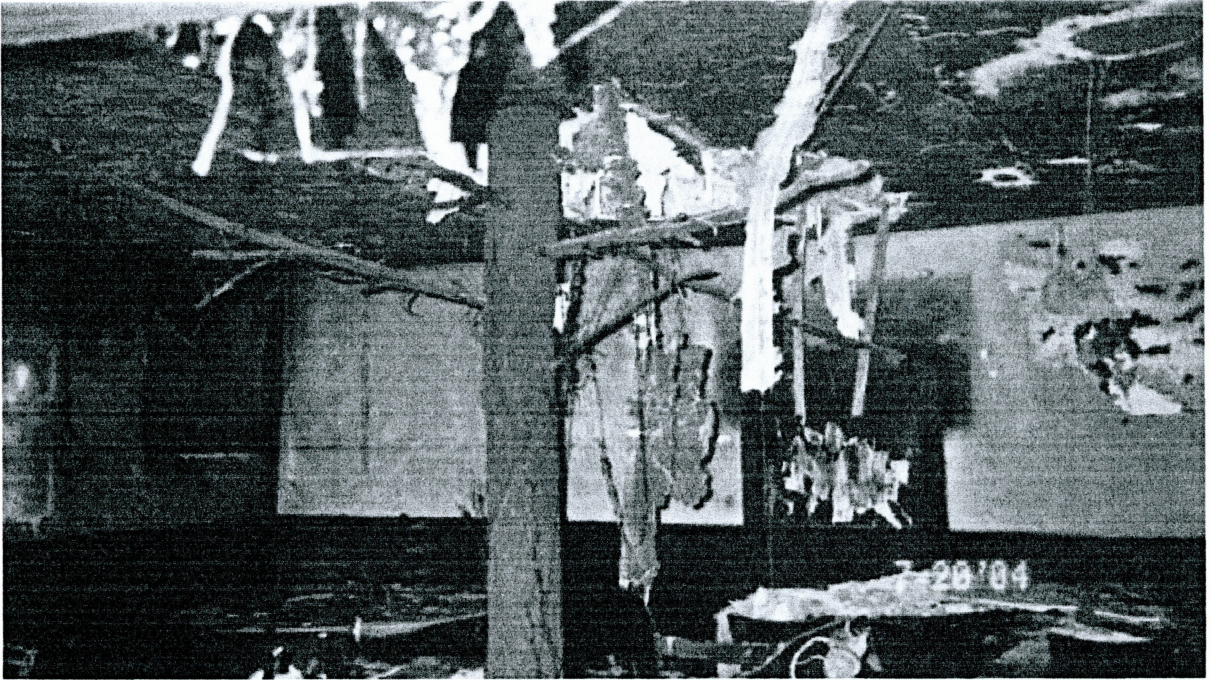
The first floor consists of a kitchen, bar, two dining rooms, a hallway and men's and women's rest rooms. The walls and ceilings are covered with a plaster finish and the floors in all rooms, except the kitchen and rest rooms, are covered with carpet. As we progressed from the rear to the front of the premises, the amount of plaster remaining intact lessened while the degree and severity of fire and water damage increased. The kitchen and bar areas contain minor to moderate fire, smoke and water damage. However, the first dining room, closest to the rear of the building, exhibits a noticeable sag in the ceiling partially exposing the wooden floor joists above. The wall finish in this dining room is generally intact with isolated areas of minor fire and smoke damage. The front dining room is the most severely damaged room on the first floor. The extent of fire damage is significant with visible charred wall studs, floorboards, and ceiling joists. Also present is a 3' x 3' (+/-) hole in the floor and ceiling directly to the right side of the room as you enter from the rear of the building. The basement and second story levels can be seen through the holes. The holes are approximately in line with one another. The women's restroom, which was in the vicinity of the front dining room, appears to be completely destroyed. However, the men's restroom, located to the right side of the front dining room, is relatively free of fire damage. Also present on the floor is a moderate amount of debris, consisting of dishes, teapots, glasses, broken bottles and trash.

**PHOTO 5 (First Level Front Dining Room - Typical Condition)**

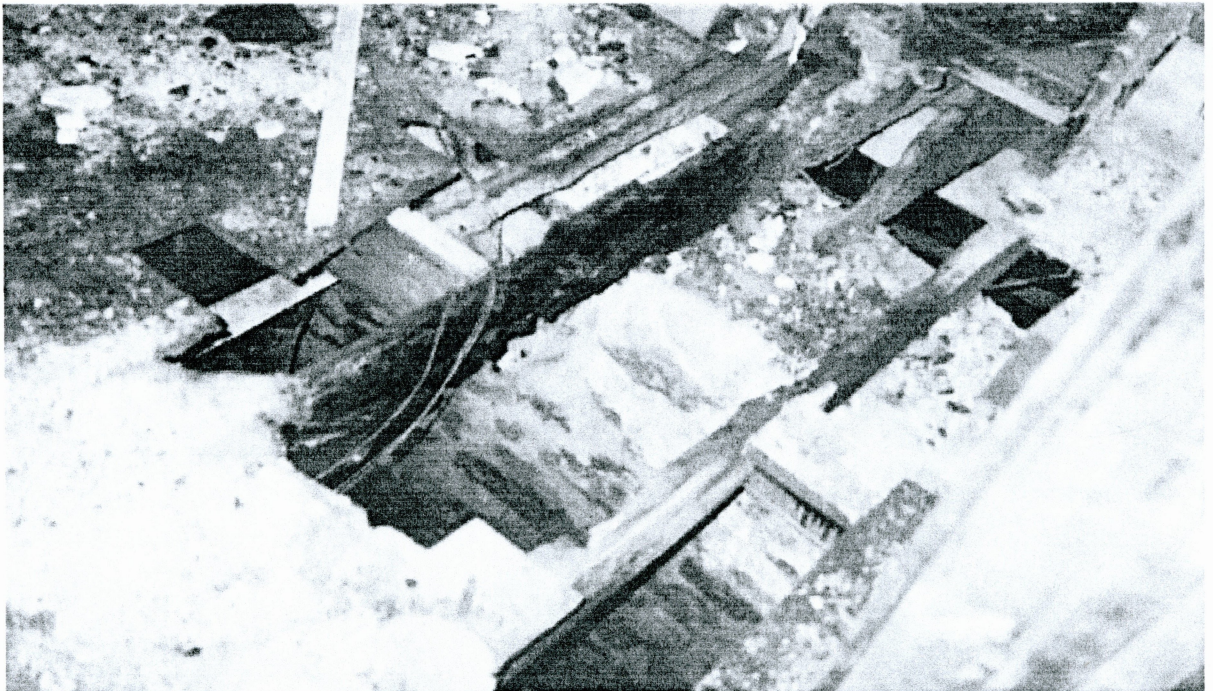
**PHOTO 6 (First Level Front Dining Room - 3'x 3' hole in floor exposing basement below)**

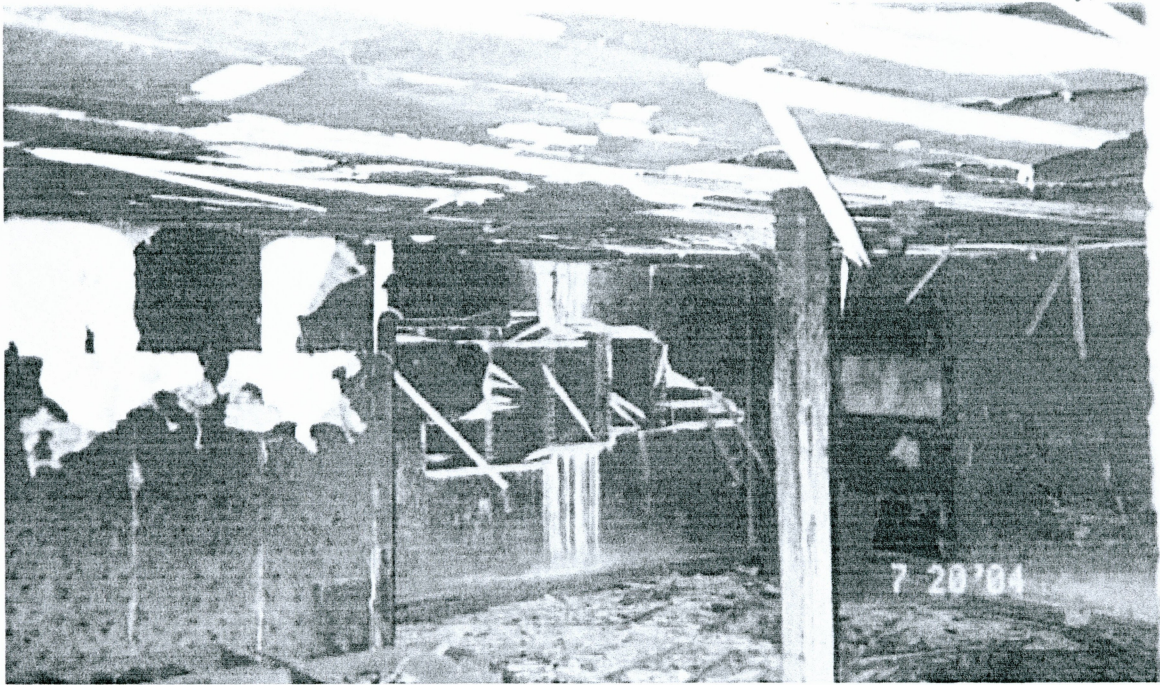
The second level consists of a hallway and three rooms. The damage to this level is consistent with that of the front dining room on the first floor. The interior and exterior wall studs, ceiling joists and floorboards are exposed and moderately to significantly charred. In some areas these elements are completely destroyed exposing the attic area and roof/sky above. The stairway leading up to the second level also contains moderate to severe fire damage on the steps and walls. The last two steps are missing exposing the front dining room below.

**PHOTO 7 (Second Floor – Typical Wall Condition)**

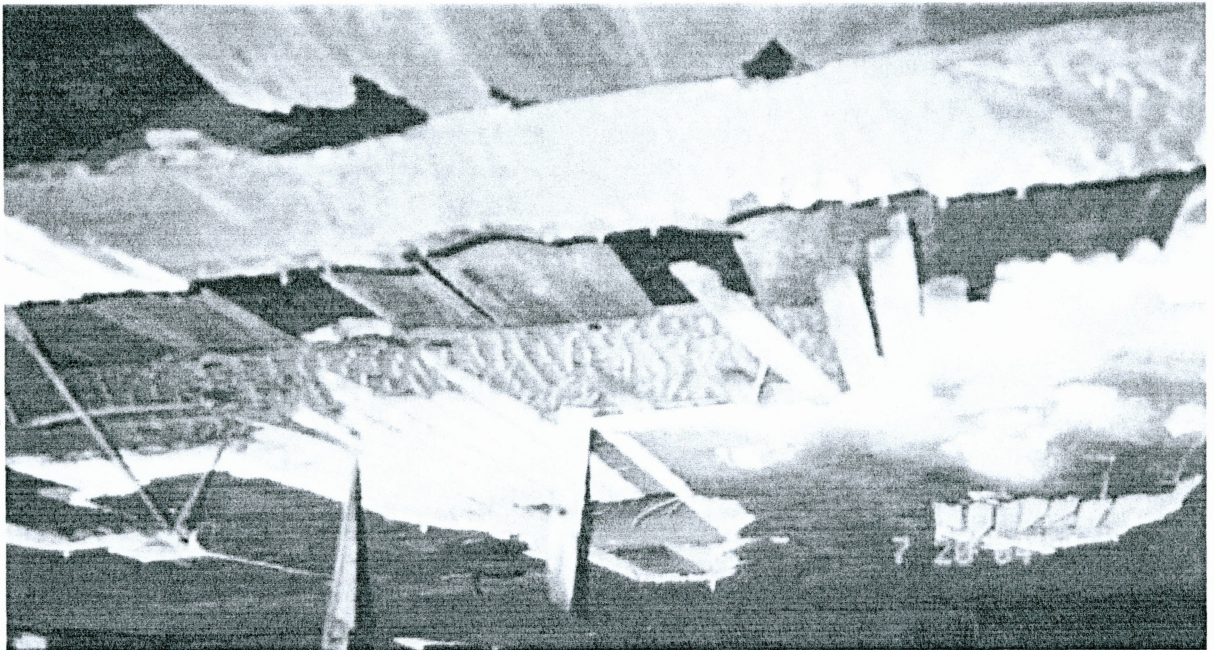
**PHOTO 8 (Second Floor – Typical Ceiling Condition)**

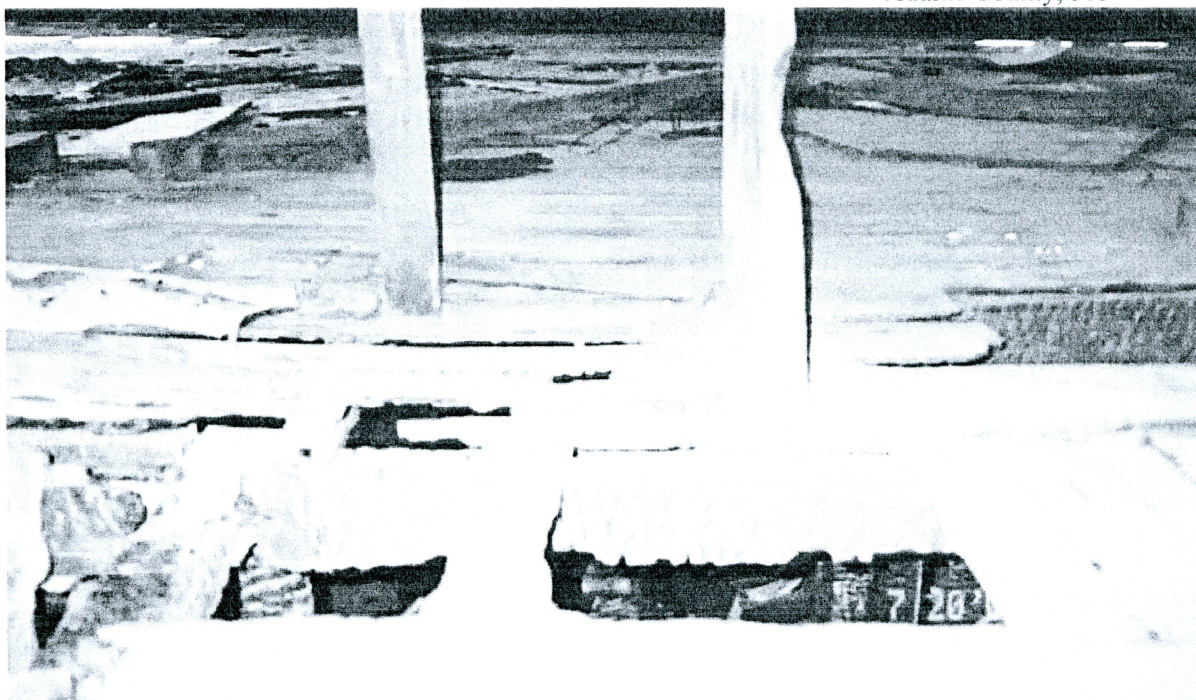
**PHOTO 9 (Attic – Hole in Floor at top of stairs)**

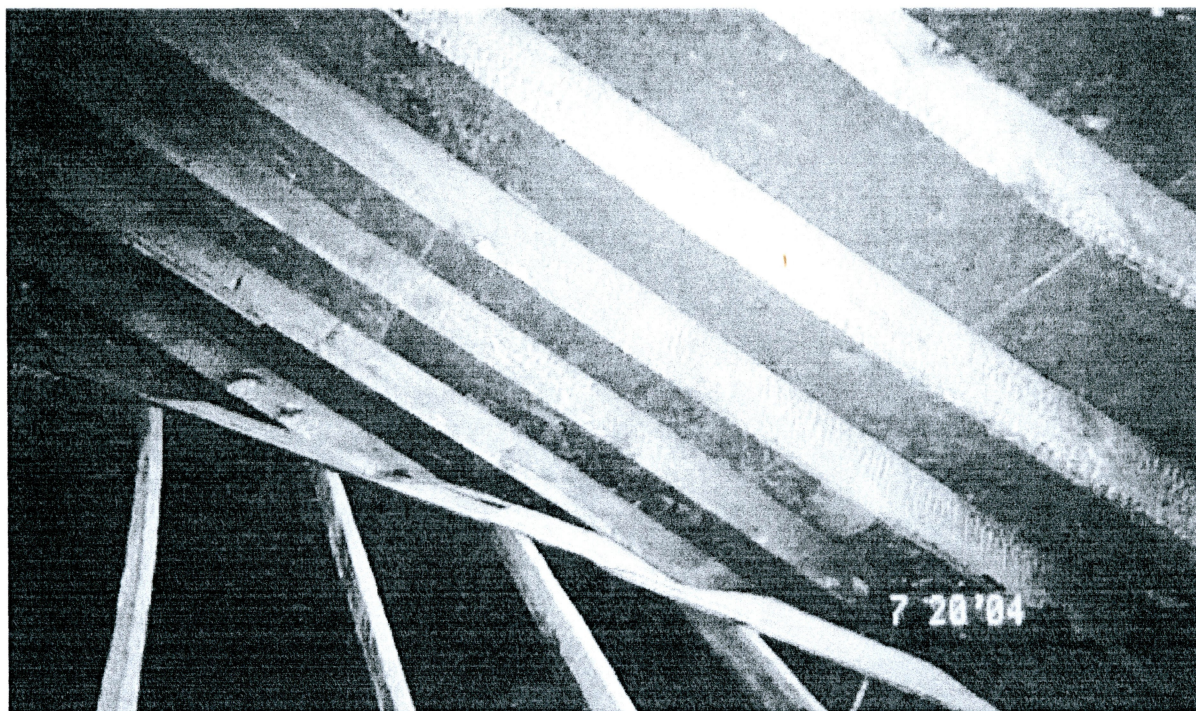
The attic area was viewed from the top of the staircase and was also found to be significantly damaged. Again, the level of fire damage is consistent with the second level. The wall studs, floorboards and roof rafters are exposed and significantly damaged by fire. A significant portion of the roof is burned out and the structure has remained open to the weather as a result.

**PHOTO 10 (Attic – Typical roof rafter condition)**
